**PAGE'S LAKE DAM**

**PHASE I INSPECTION REPORT.**  
**NATIONAL DAM INSPECTION PROGRAM**

PAGE'S LAKE DAM  
SUSQUEHANNA COUNTY, COMMONWEALTH OF PENNSYLVANIA  
NDI No. PA 00062  
PennDER No. 58-5

Page's Lake Dam, Susquehanna County, Pennsylvania  
NDI No. PA 00062, PennDER No. 58-5  
Salt Lick Creek  
Inspected 27 October 1980

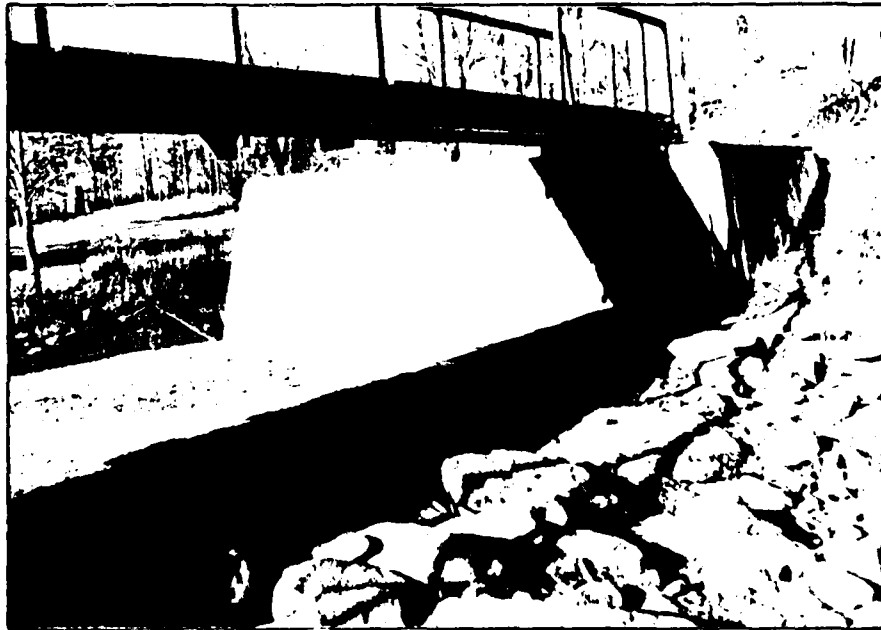
PHOTO 2. Close-up of Spillway Crest

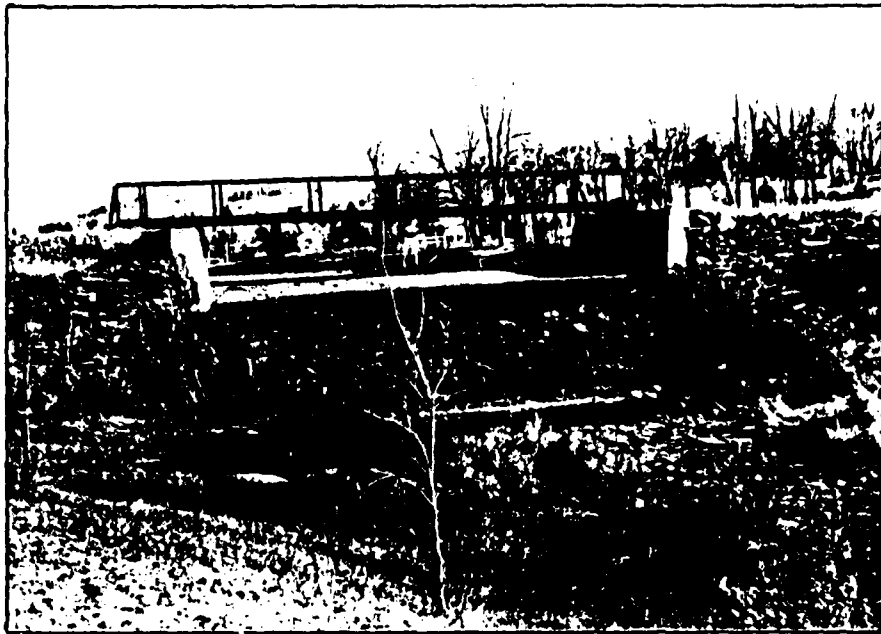
The right spillway training wall has cracks and spalling on the downstream face. However, this is not considered significant enough at this time to require repair.

PHOTO 3. View of Downstream Side of Spillway

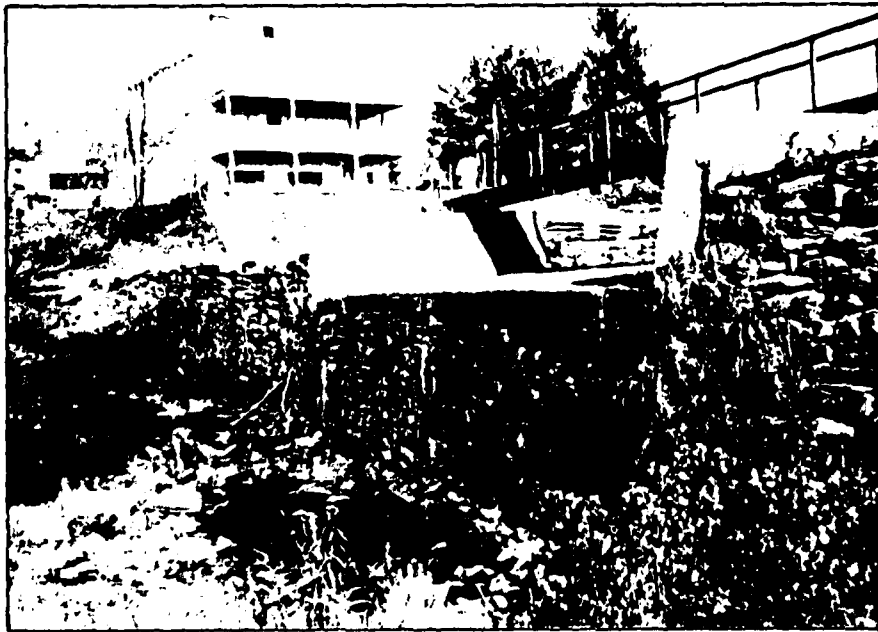
PHOTO 4. Oblique View of Downstream Side of Spillway and Dam from Left Abutment

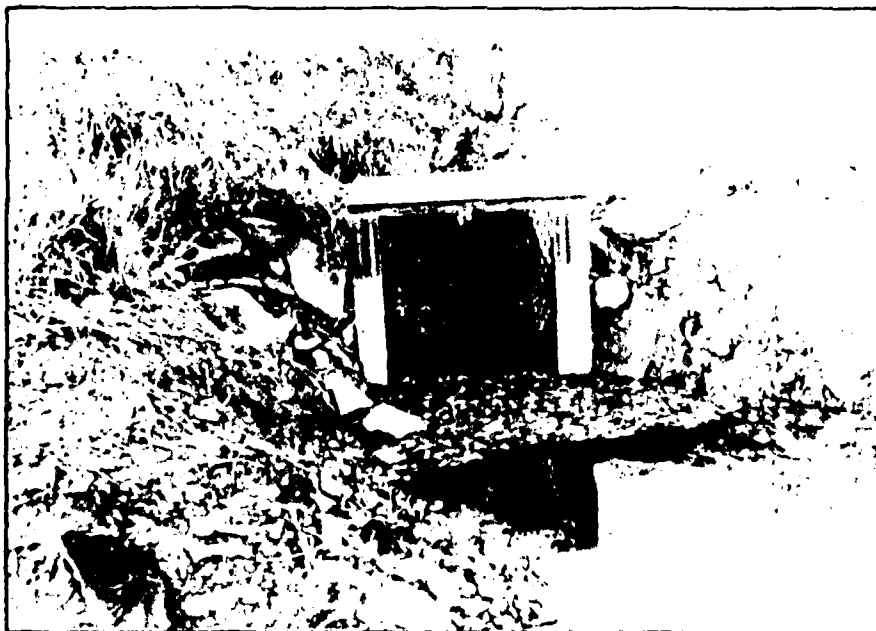
PHOTO 6. Close-up View of Intake for Outlet Conduit

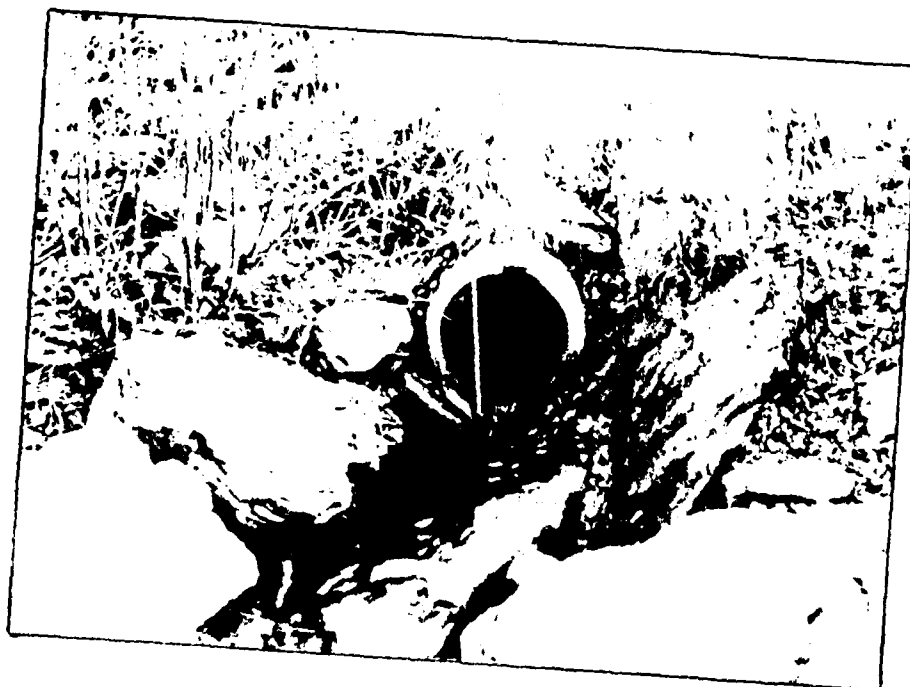
PHOTO 8. Close-up View of Downstream End of Outlet Conduit
